Matsell Cottage  
Northwest Corner of Township Road 229 and Illinois Route 1  
Brownsville Vicinity  
Carmi Township  
White County  
Illinois

HABS No. IL-1184

HISTORIC AMERICAN BUILDINGS SURVEY

MATSELL COTTAGE

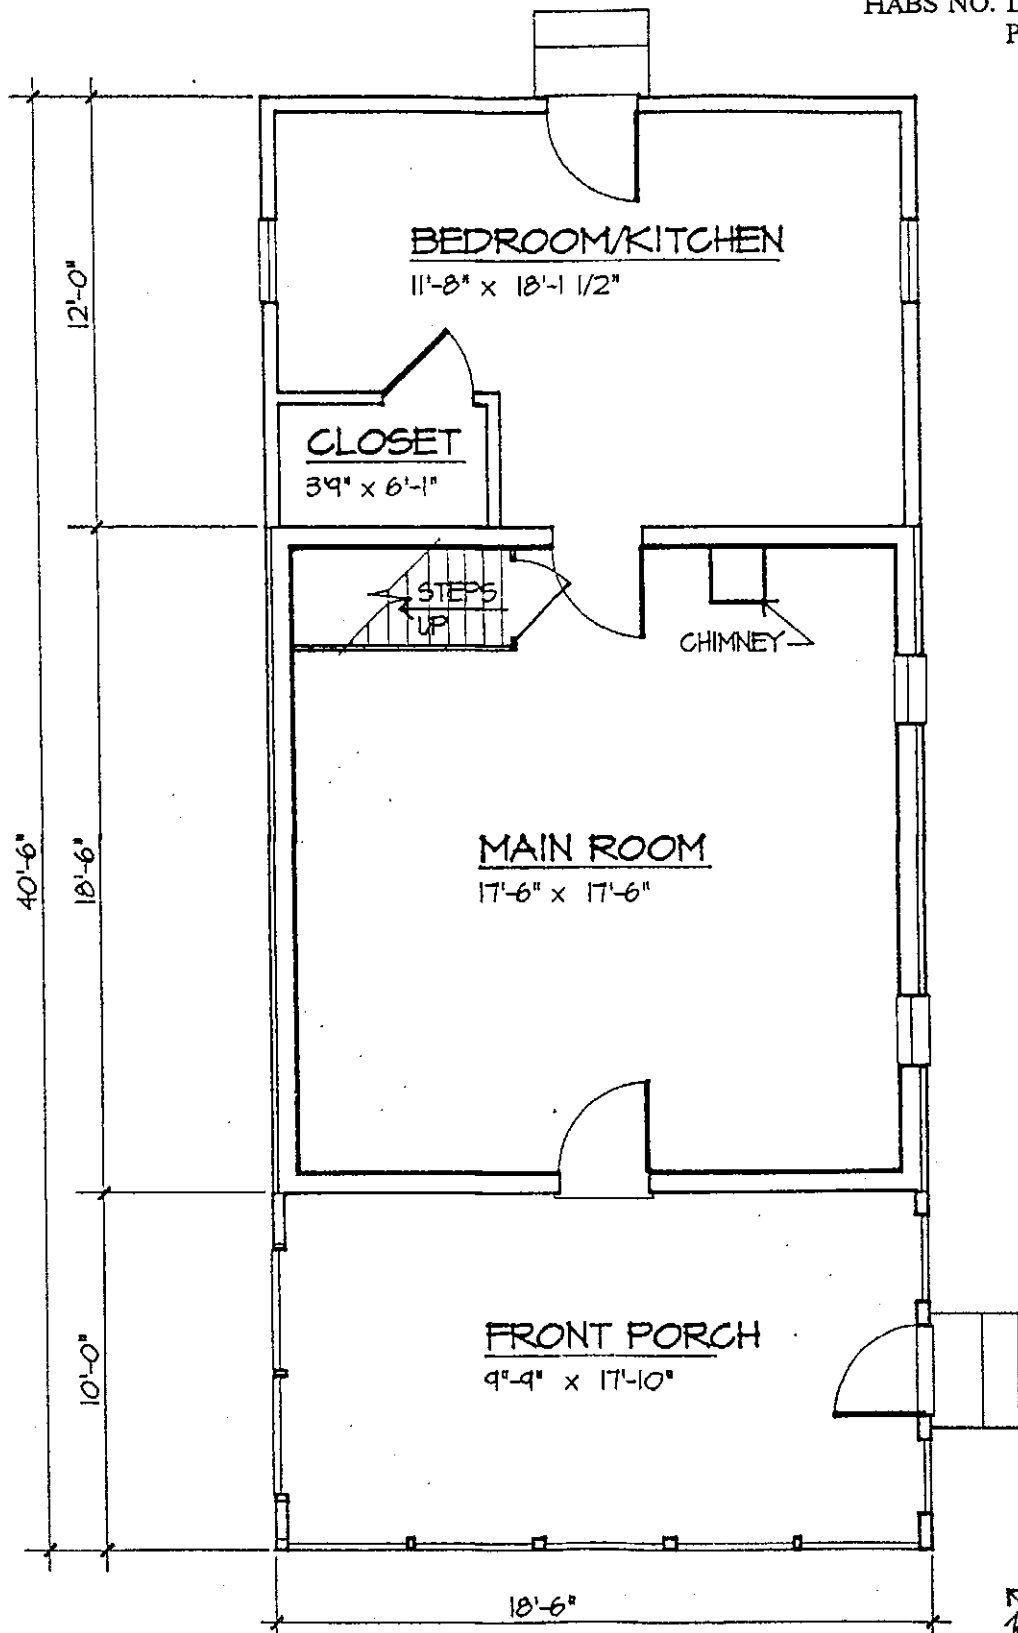
# 1ST FLOOR PLAN

Main Small Room: Approximately 17'-6" square (interior dimensions) with the main door to the entry porch area centered on south wall and the door to the kitchen area centered on north wall. The short stairsteps to second floor are along the north wall going up to the northwest corner (beginning at the kitchen door). These stairs have been enclosed with a thin stud wall and solid 1" thick wood boards with a 1" thick door at the bottom. Two four-over-four double hung windows are located on the east wall.

Front Porch: 9'-9" (north-south) x 18'-0-3/4" (east-west) with a 6'-6" ceiling has continuous windows on two sides and two windows and center two panel entry door on the east side. The north wall (face of logs) is covered with 1/2" thick painted clapboard siding (4-1/2 to 4-3/4" exposure). The other three sides of the porch room are unfinished (exposed painted wood).

Kitchen: The north backroom kitchen is 11'-8" (north-south) x 18'-1-1/2" (east-west) and has a 7'-2" (varies) ceiling. A 3'-9-1/2" x 6'-1" closet exists in the southwest corner with 2'-0" x 6'-0" high door. A six-over-six double hung window is located centered on the east and west walls.

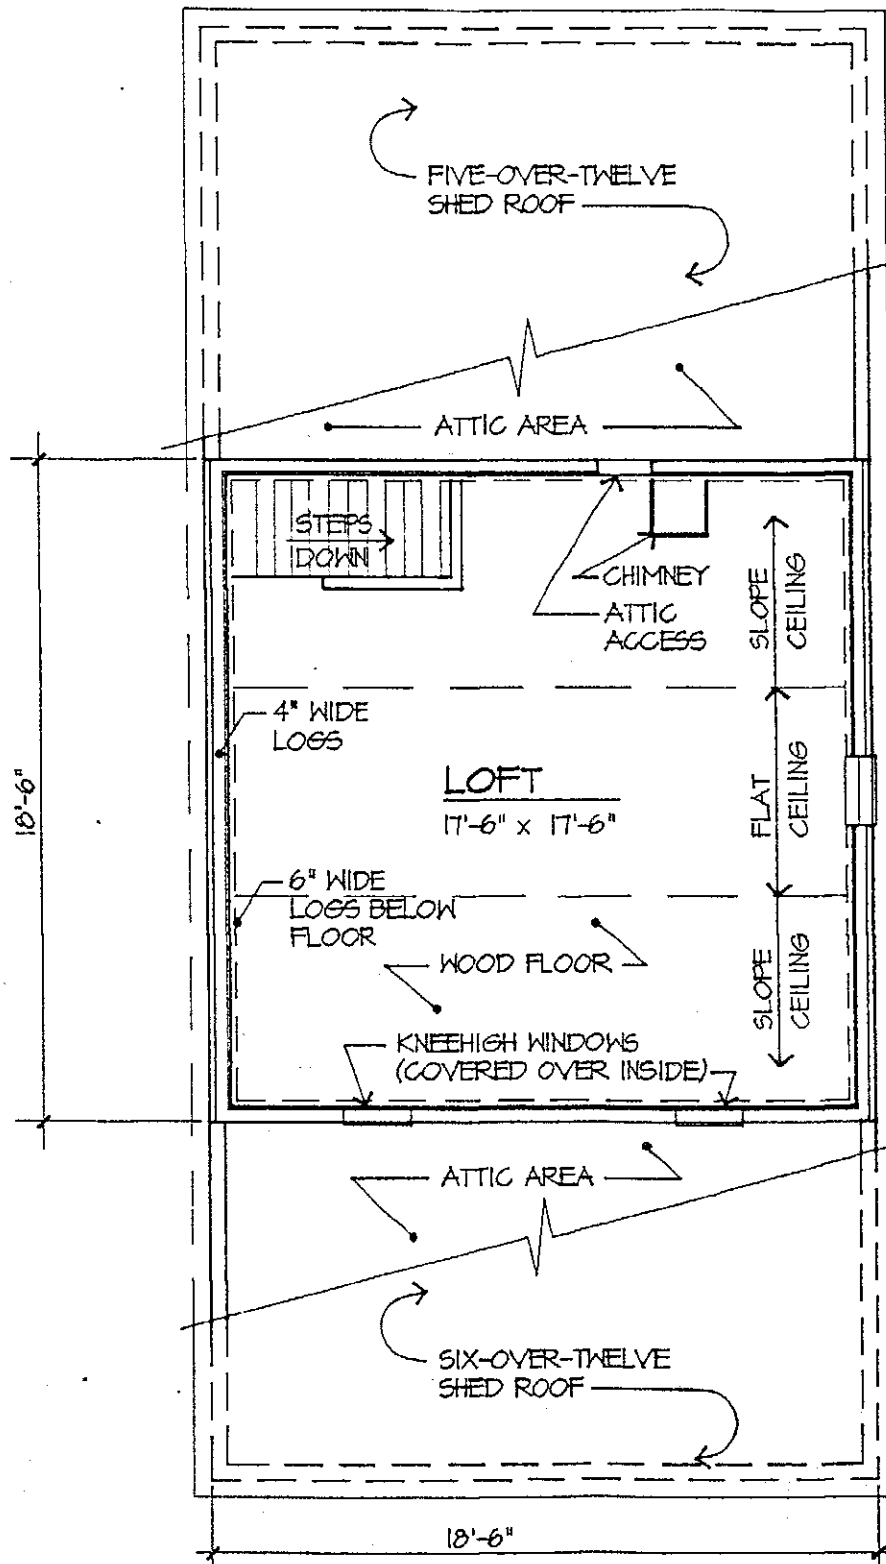
## 2ND FLOOR PLAN

Approximately 17'-6" square with irregular east and west end gable end walls (logs up to 46" with flat stud framing and lap siding up to roof). The north and south side walls are logs up 46" to 48" where rafters bear. The ceiling from these north and south walls slopes up to the flat center section, the height of which varies (7'-7" to 7'-10"). A single six-over-six double hung window is located on the east wall and two small square window openings (now covered over) still exist down low near the floor on the south wall.
